# WGSL Final Report for Sedimentation Basin Restoration

Please find a copy of the final report documenting the restoration of the sedimentation basin located at the Waimanalo Gulch Sanitary Landfill.

Subject: Sedimentation Basin Restoration Observation Report, Waimanalo Gulch Sanitary Landfill, Kapolei, HI

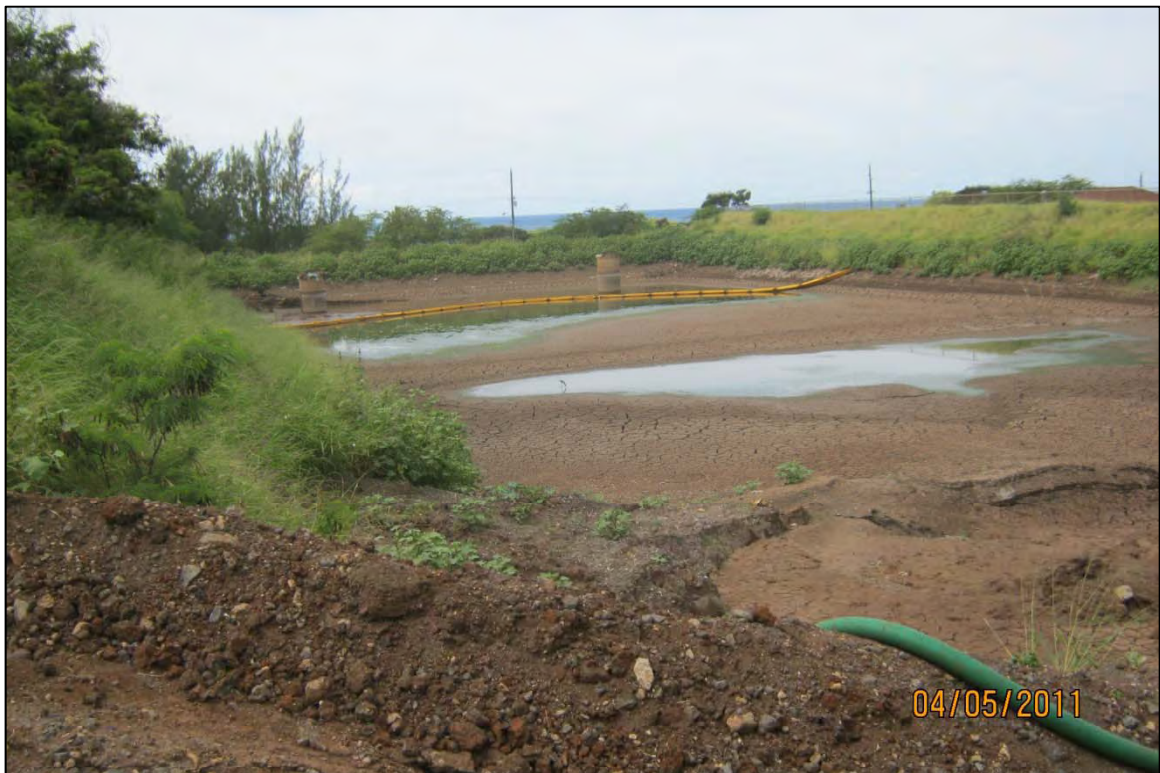
Photo 4: Sedimentation basin in April 2011 while pumping by WMH, looking southwest.

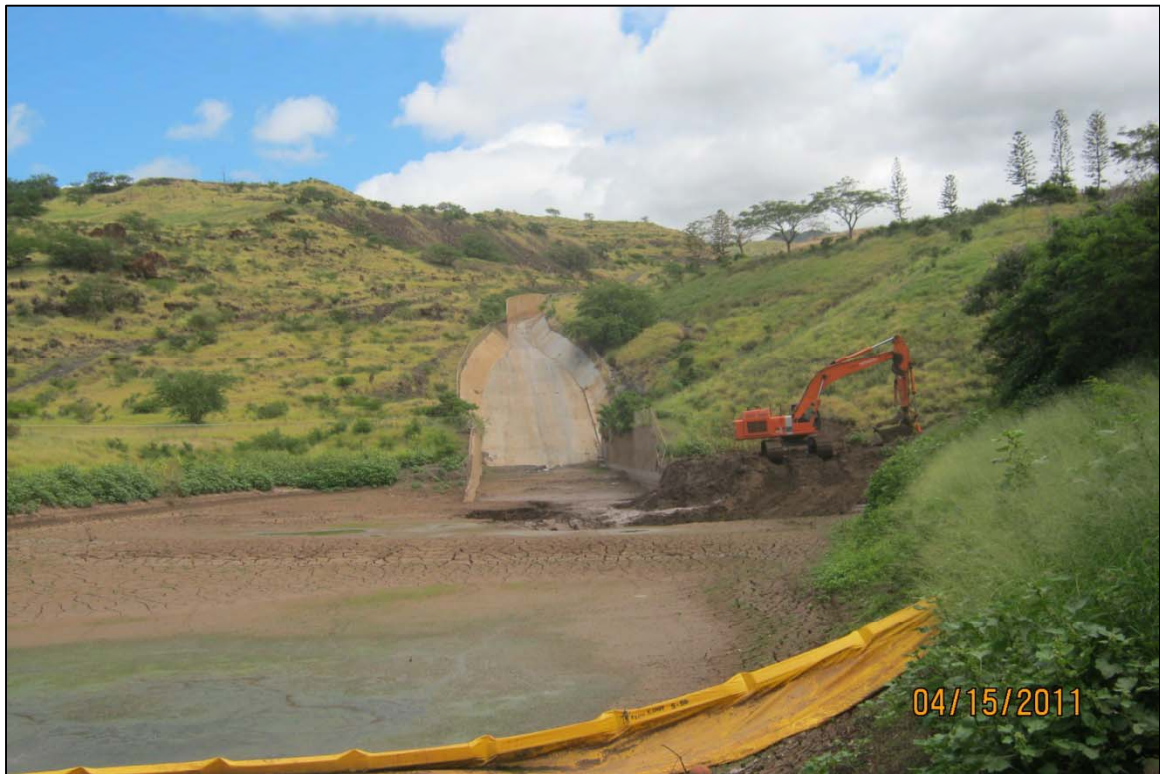
Photo 5: Beginning excavation of sediment within the northern portion of the sedimentation basin, looking north.

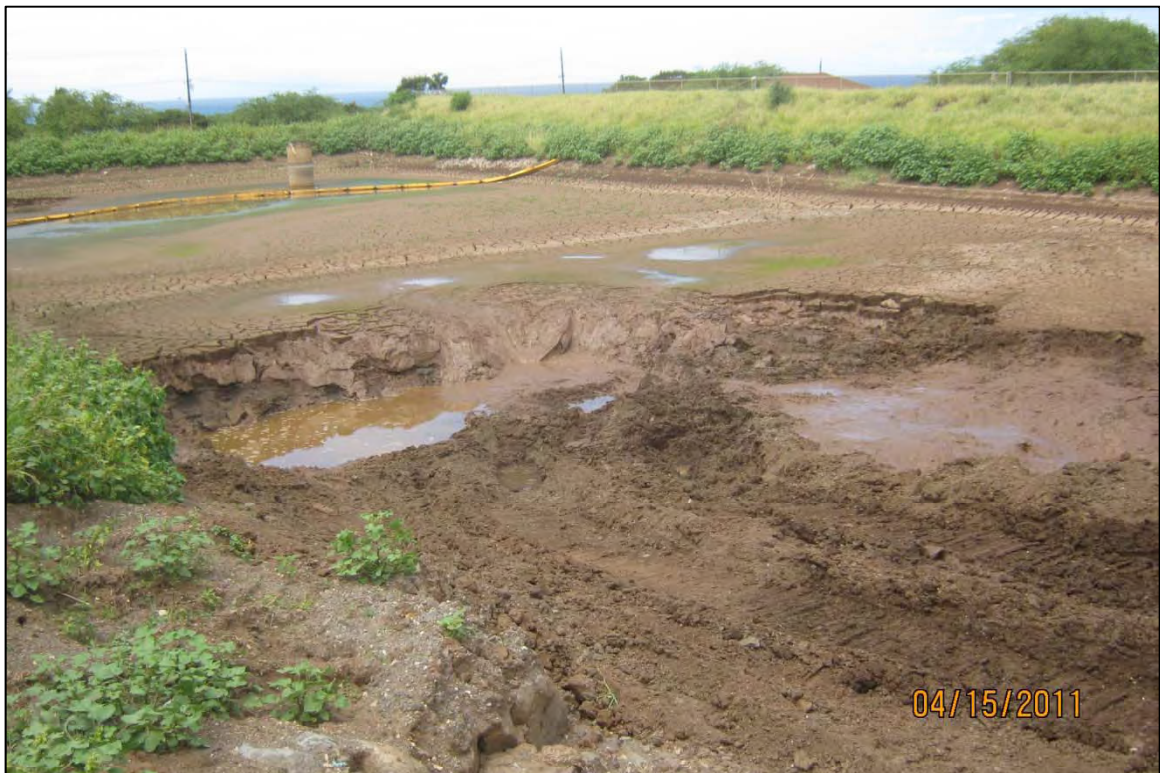
Photo 6: Excavation of sediment in northern portion of the sedimentation basin, looking southwest.

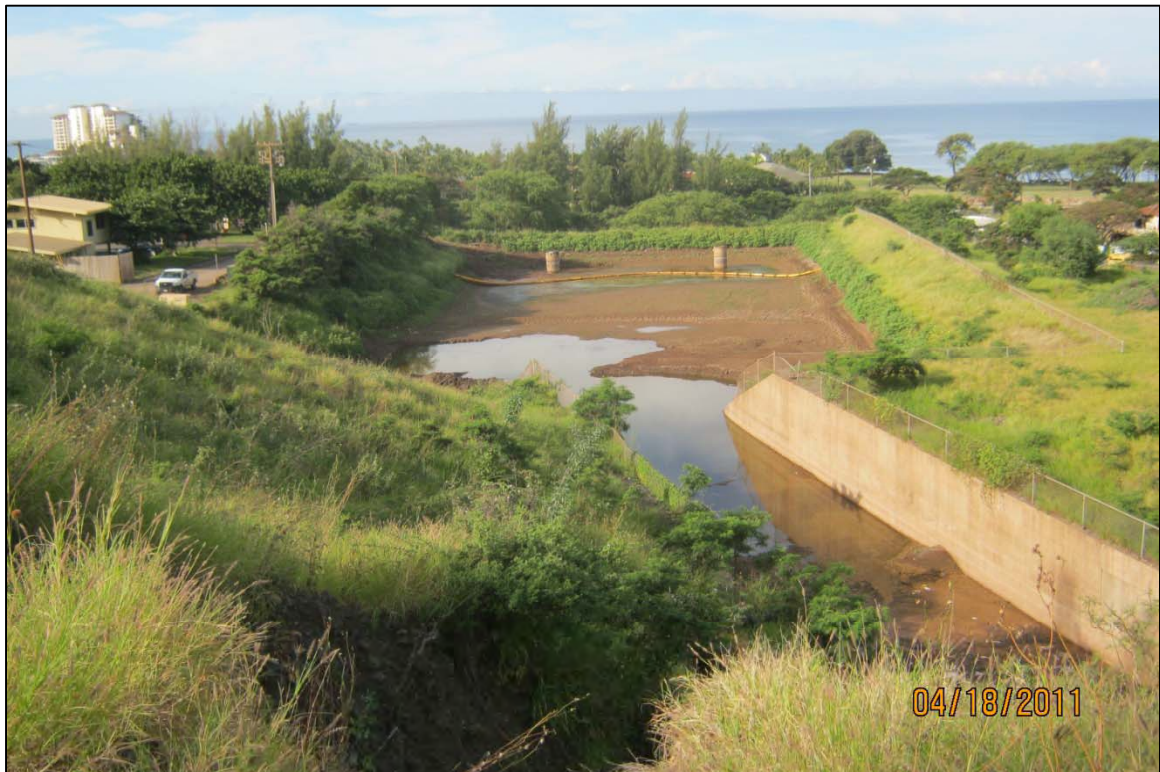
Photo 7: Sedimentation basin following additional rain which filled the excavation in the northern portion with storm water, looking south.

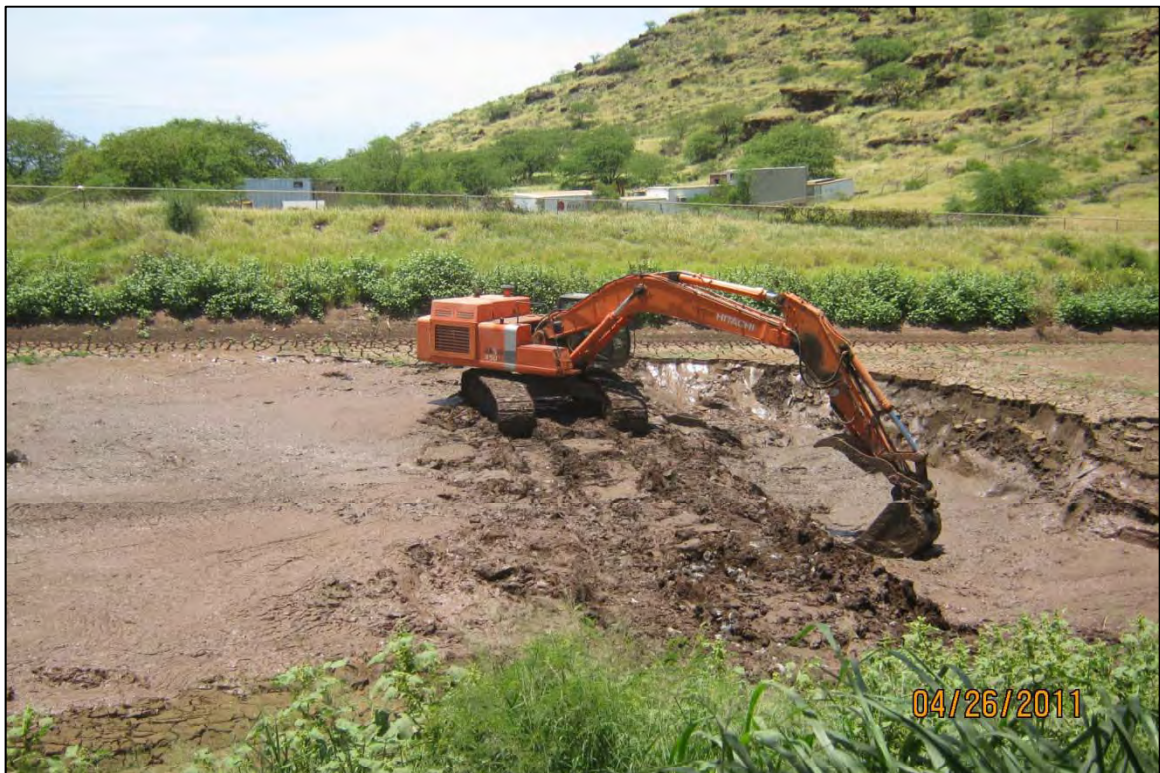
Photo 8: Continuing excavation of sediment in the northern portion following pumping of storm water, looking west (excavator sitting on interior berm).

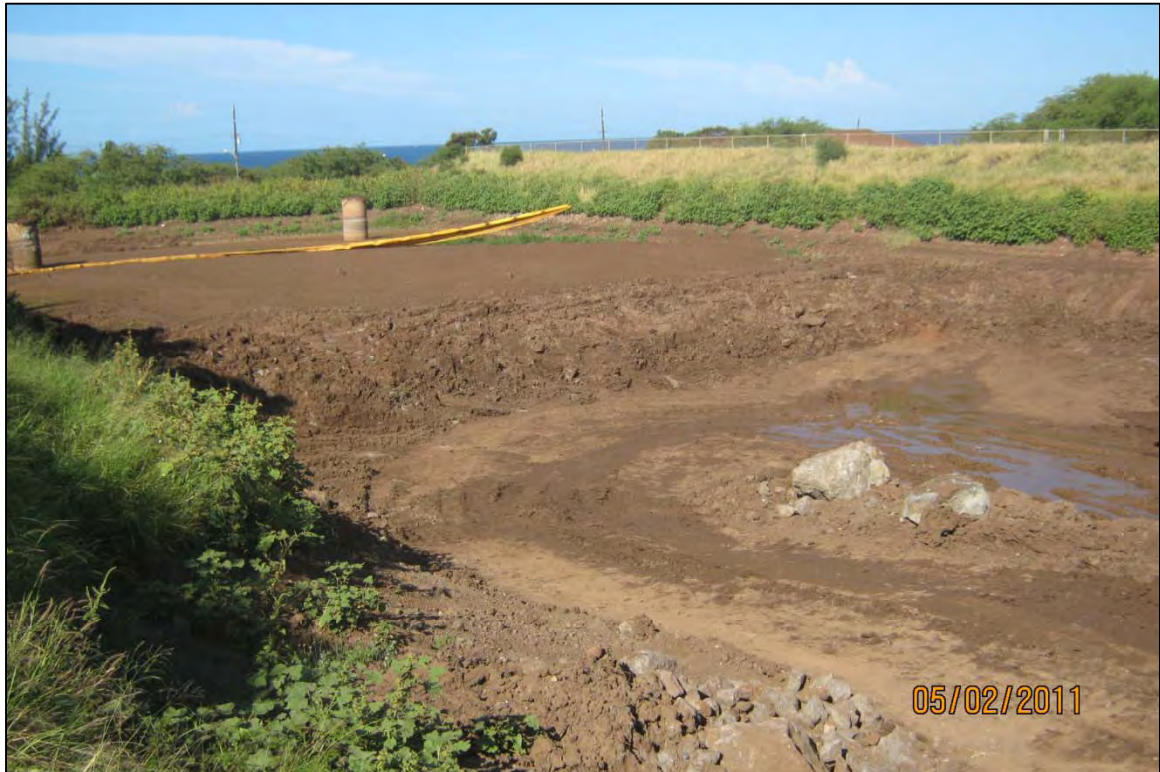
Photo 9: Northern portion of the sedimentation basin following removal of ~2/3 of accumulated sediment, looking southwest.

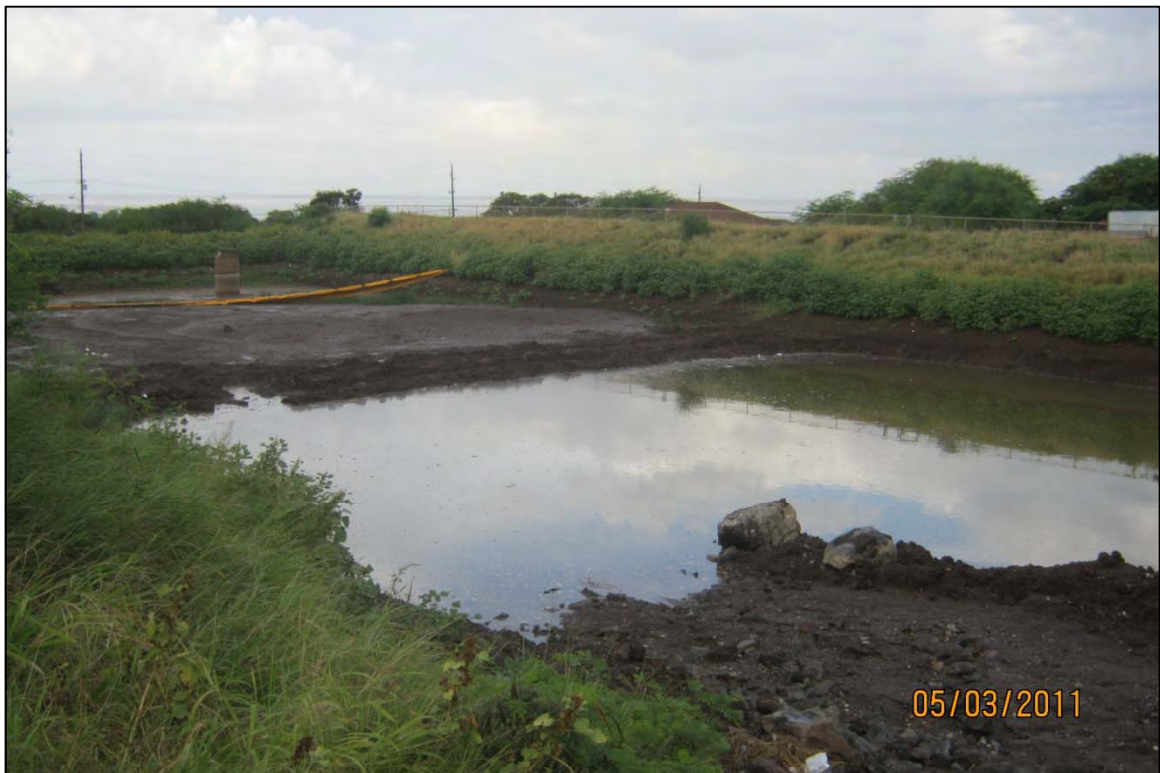
Photo 10: Northern portion of the sedimentation basin following additional rain which filled the excavation in the northern portion with storm water, looking southwest.

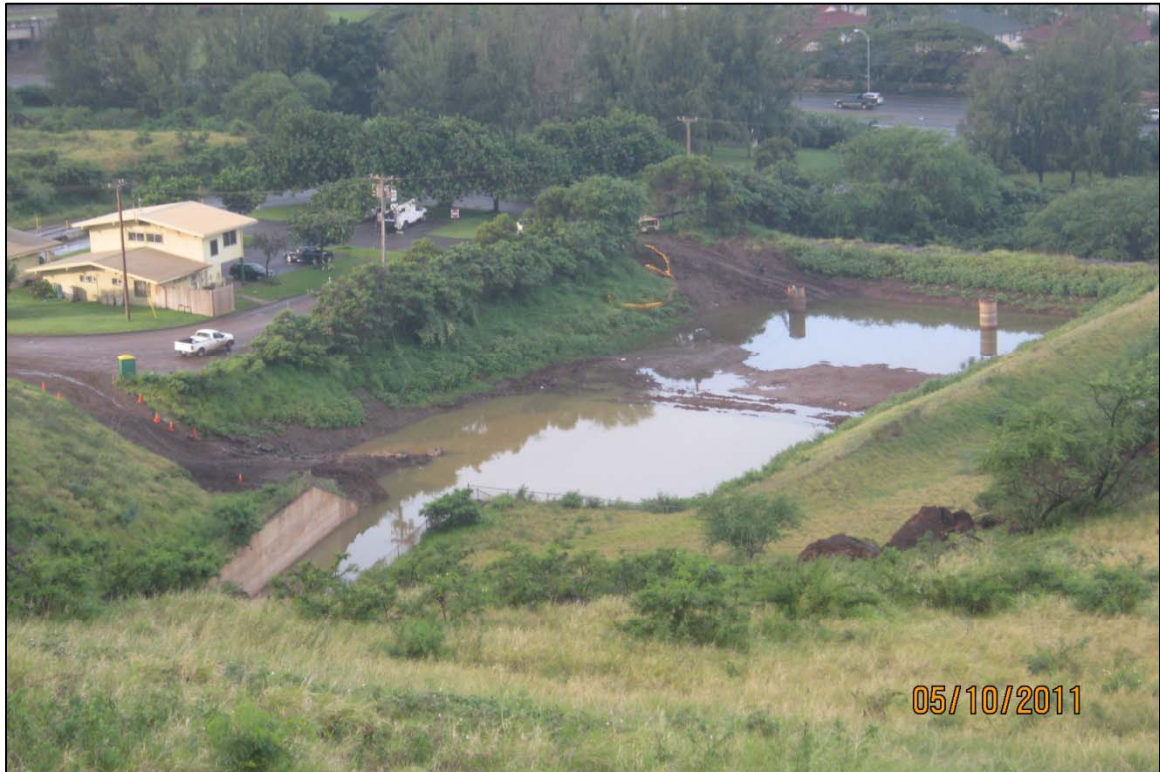
Photo 11: Overview of the sedimentation basin following a rain event in May 2011 which placed additional storm water in both the northern and southern portions of the basin.

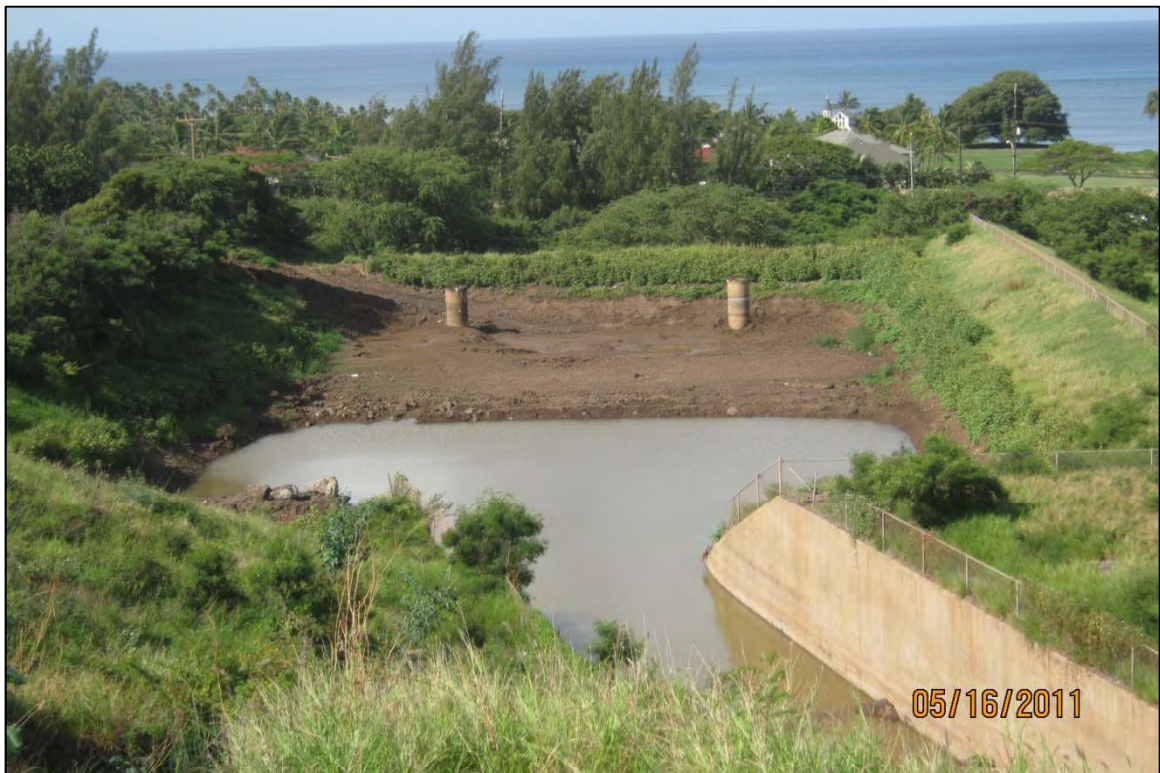
Photo 12: Sedimentation basin following pumping of storm water in the southern portion, looking south.

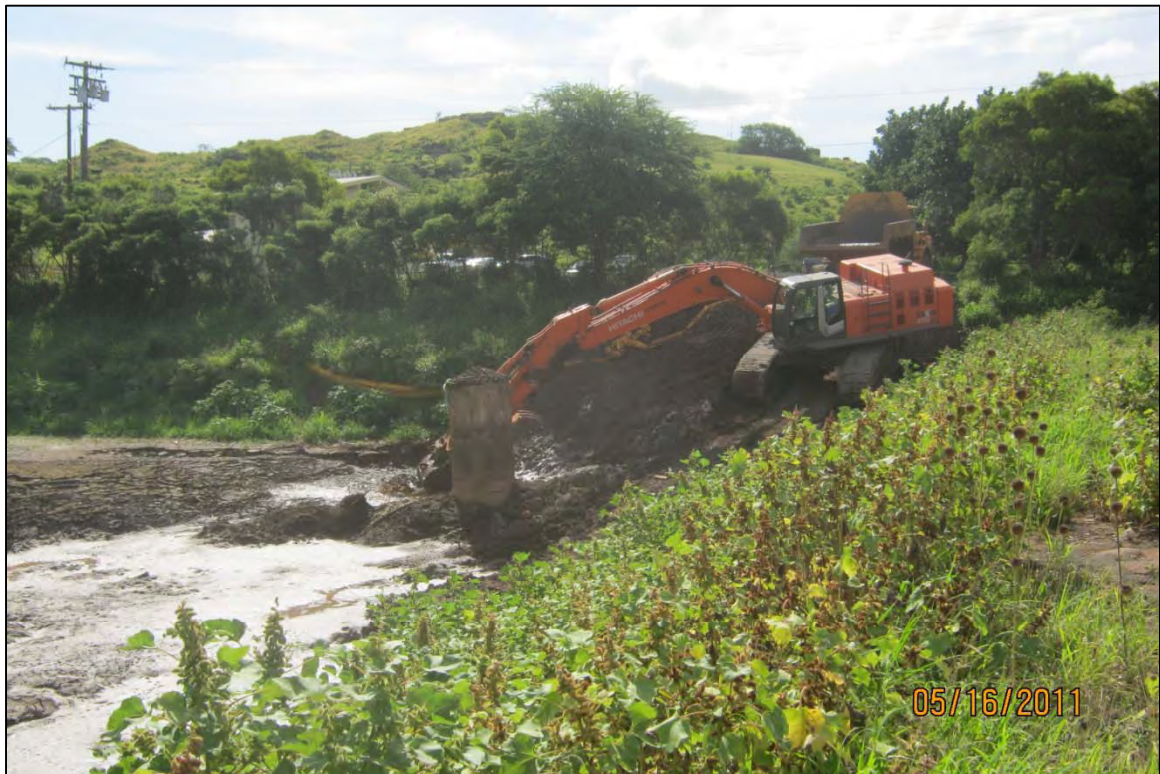
Photo 13: Excavating sediment around the concrete riser in the southern portion of the sedimentation basin, looking east.

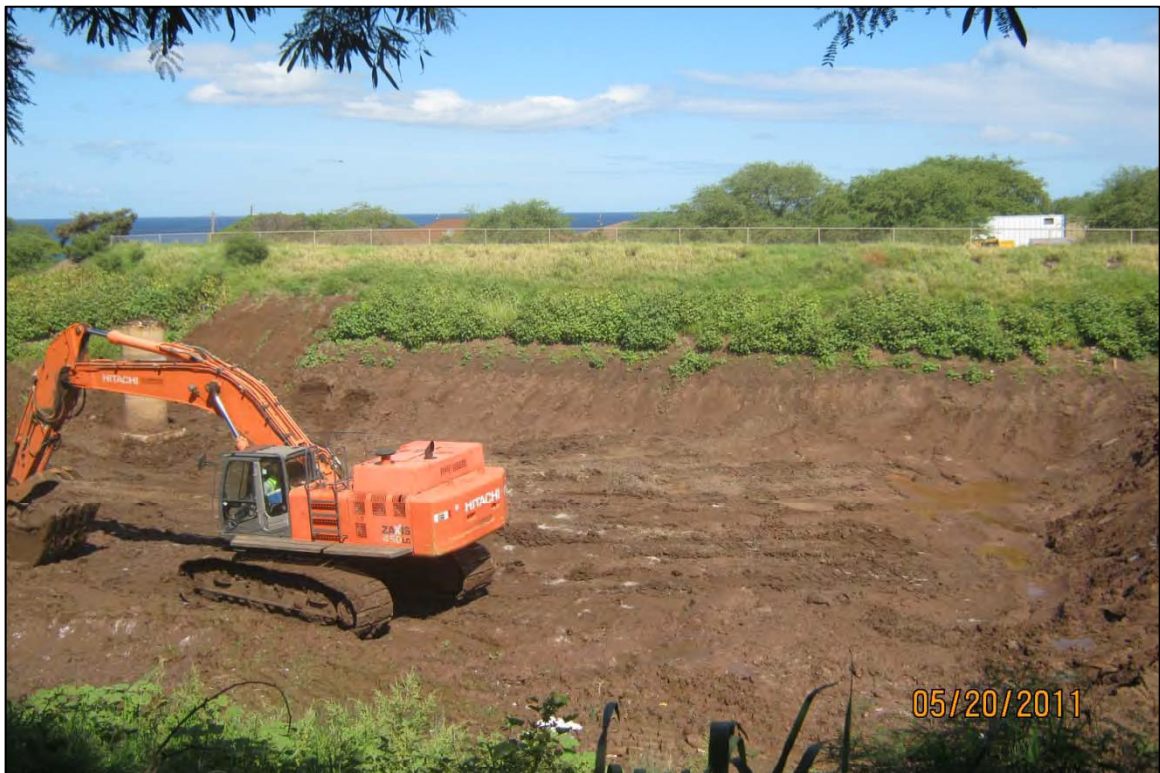
Photo 14: Southern portion of sedimentation basin following removal of sediment from basin floor and sideslopes, looking west.

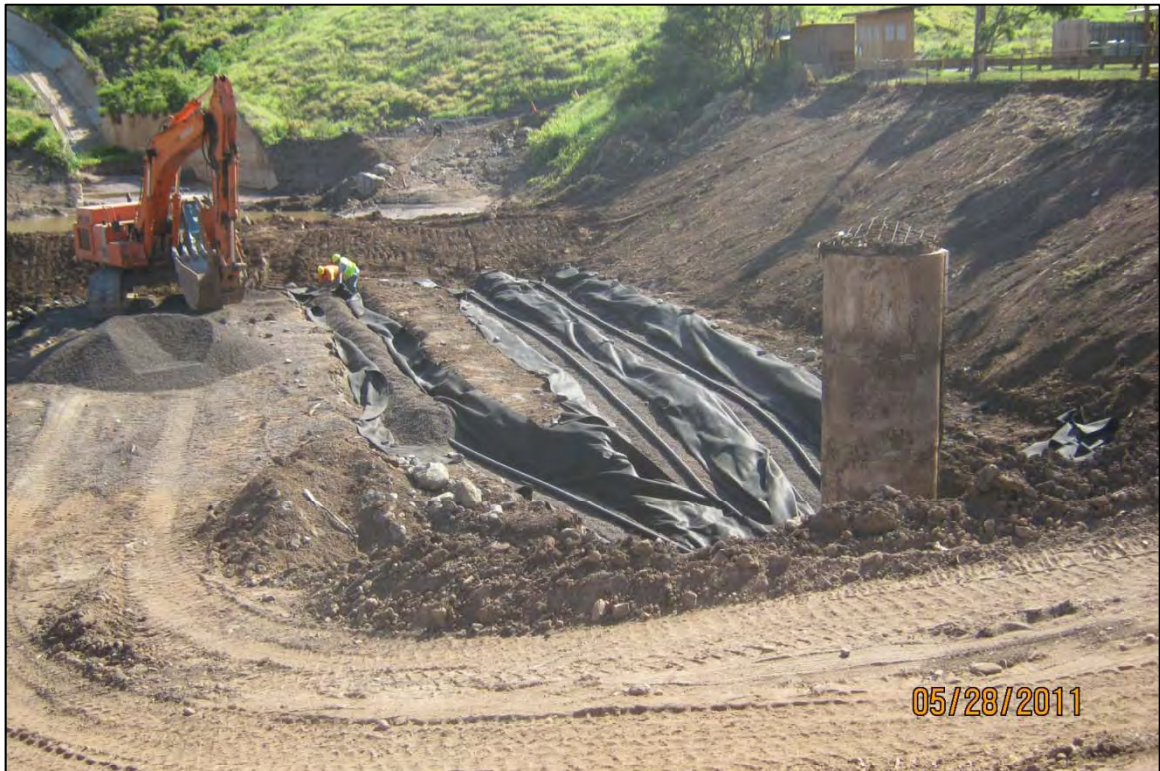
Photo 18: Placing drainage gravel over the subdrain pipes on the eastern side of the sedimentation basin, looking northeast.

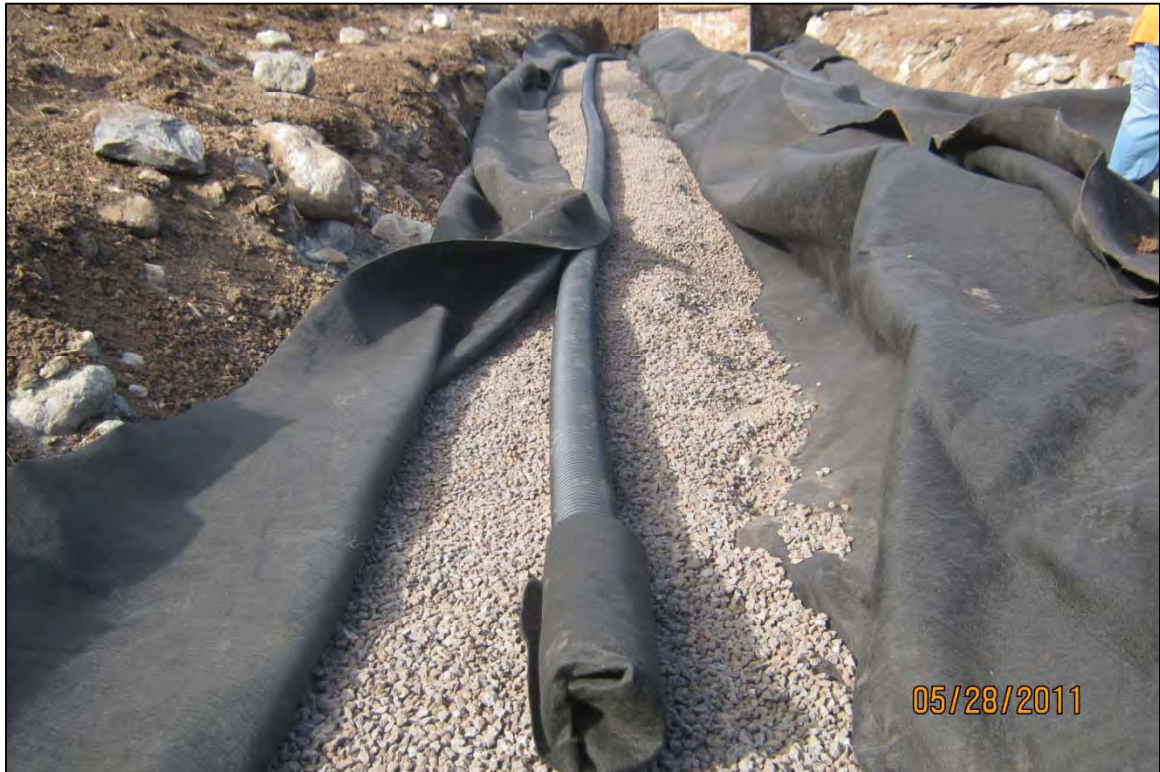
Photo 21: Geotextile wrap around the upstream end of the subdrain pipe, looking south.

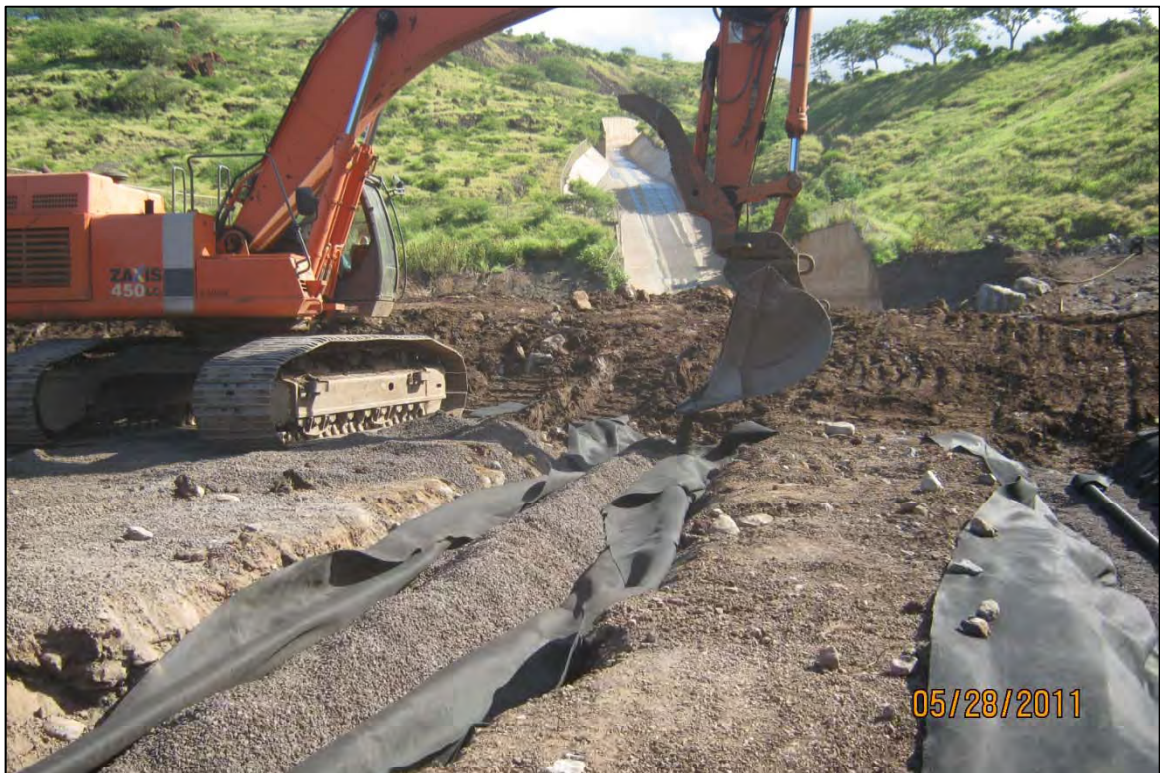
Photo 22: Placing drainage gravel over the subdrain pipes prior to encapsulating with the 16-oz/yd<sup>2</sup> geotextile filter fabric on the eastern side of the sedimentation basin, looking northeast.

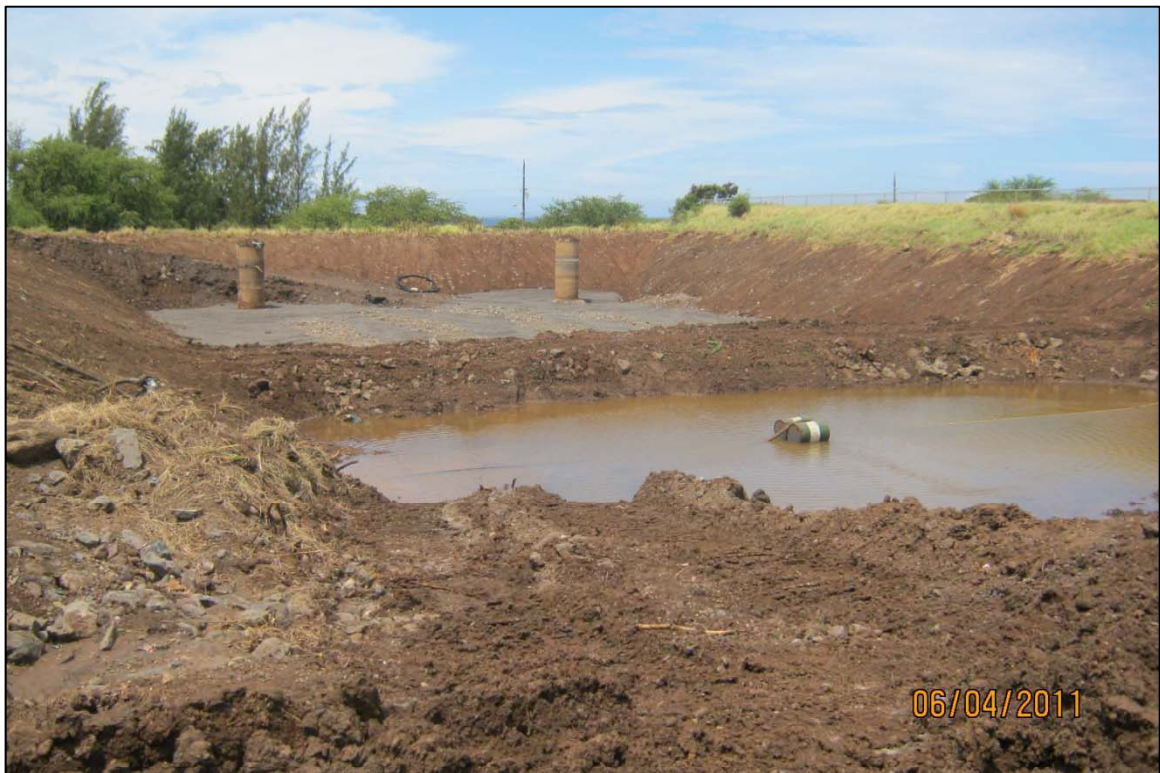
Photo 24: Pumping water from the northern portion of the sedimentation basin following additional storm water at the site on June 3, 2011, looking southwest.

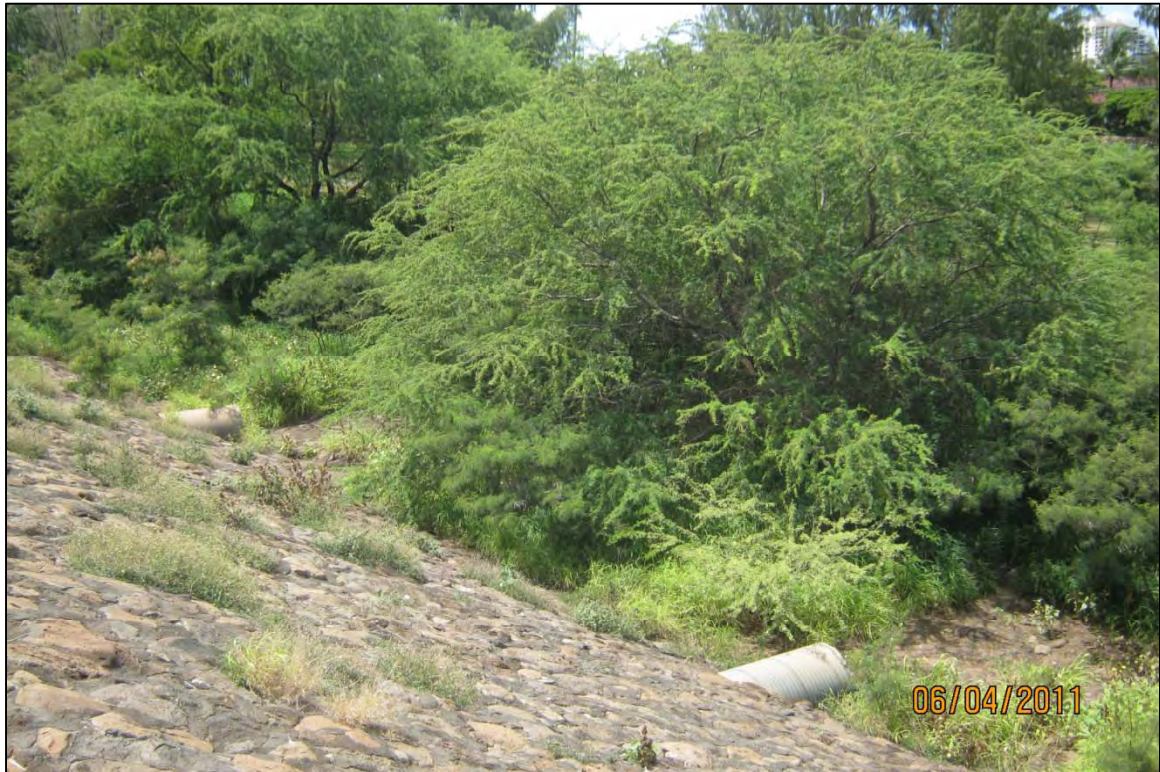
No debris or bare soil was observed within the vegetated drainage corridor following sedimentation basin restoration activities. In addition, no damage, debris or sediment was observed at the 42-inch CMP outfalls into the vegetated drainage corridor.

Photo 27: Overview of the riprap embankment and the 42-inch CMP's discharge areas into the vegetated corridor, looking southeast.

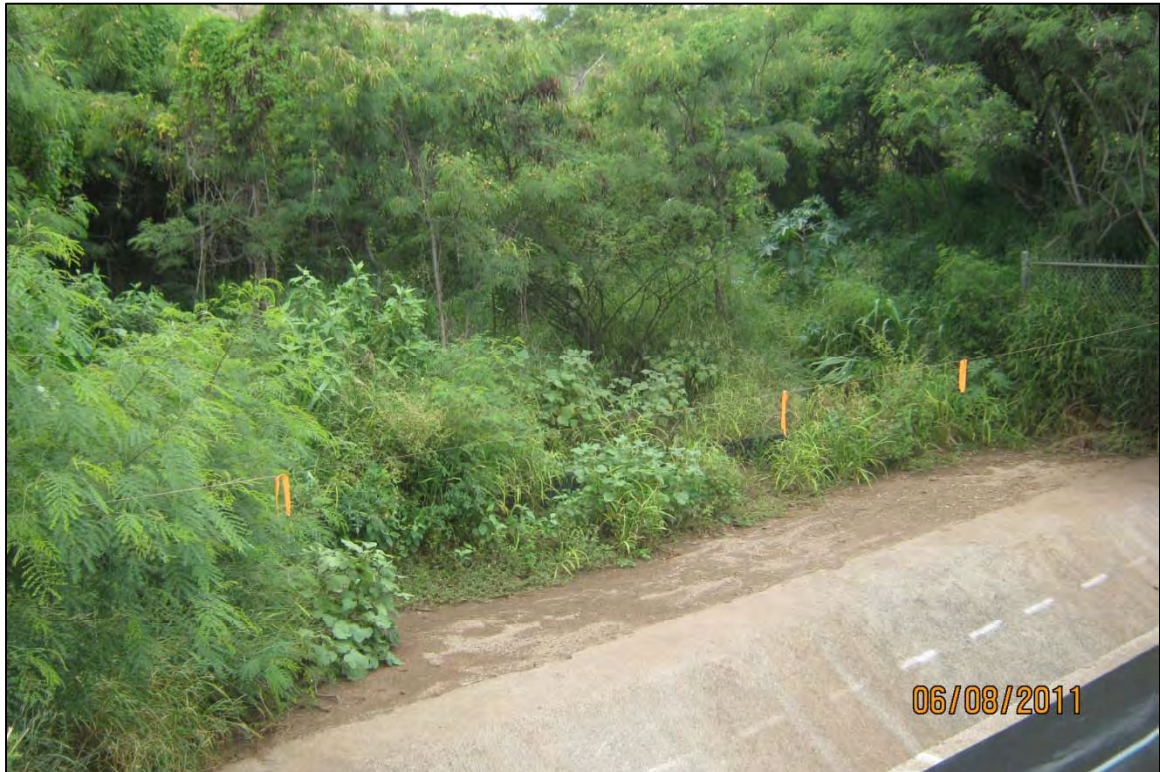
Photo 29: Overview of the spillway at the southern edge of the vegetated corridor, looking east.
